Manhole Inspection Summary

Manhole # S47C__024MH

Inspection ☐ Is Incomplete Rating: **3) Fair**

Location Address: **Chester**

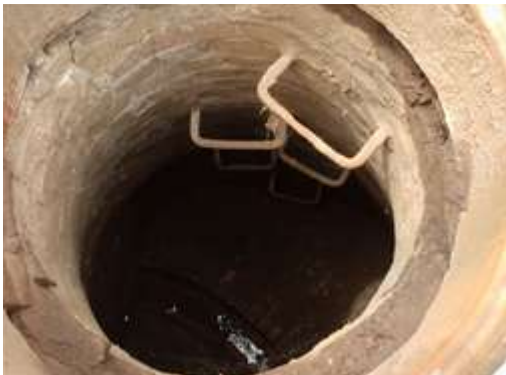
Defect 1

frame leaks

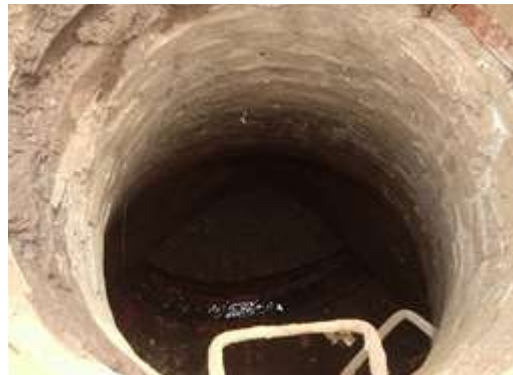
Defect 2

infiltration

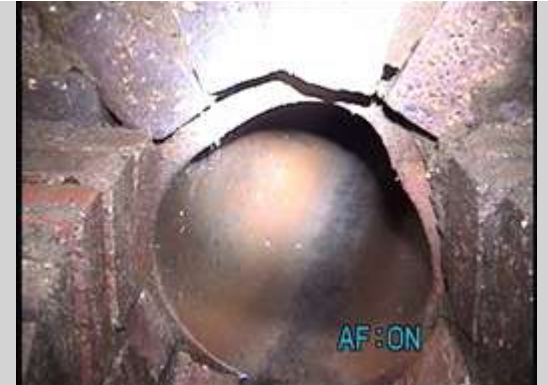
12 O'Clock Outflow

8 in. Circular Gravity Sewer
Pipe Out @ 12 O'Clock

Pipe Height: **8.4** (in.) Rod and Bar (Angled)
Pipe Material: **Clay** ☐ Pipe Lined
Invert Depth: **9.00** (ft.) Flow Characteristics: **Slow**
Deposits: ☒ None ☐ Mud ☐ Sludge ☐ Debris ☐ Grease
Silt Depth: (in.) Deposits Extent:
Infiltration: **None** Pipe Seal Cond: **Sound**

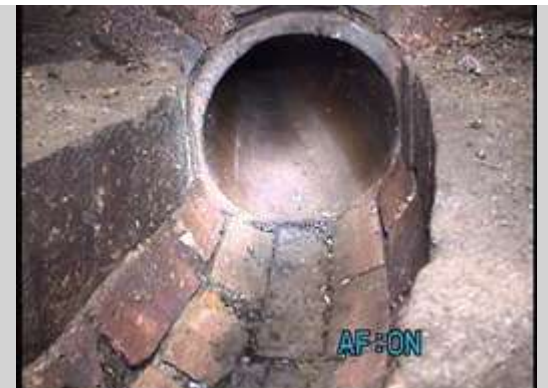
4 O'Clock Inflow

8 in. Circular Gravity Sewer
Pipe In @ 4 O'Clock

Pipe Height: **8.4** (in.) Rod and Bar (Angled)
Pipe Material: **Clay** ☐ Pipe Lined
Invert Depth: **8.90** (ft.) Flow Characteristics: **Slow**
Deposits: ☒ None ☐ Mud ☐ Sludge ☐ Debris ☐ Grease
Silt Depth: (in.) Deposits Extent:
Infiltration: **None** Pipe Seal Cond: **Sound**
